DOE/NE-ID-11206

***FY-04 Annual Operations Report for INTEC
Operable Unit 3-13, Group 1, Tank Farm
Interim Action***

FY-04 Annual Operations Report for INTEC Operable Unit 3-13, Group 1, Tank Farm Interim Action

December 2004

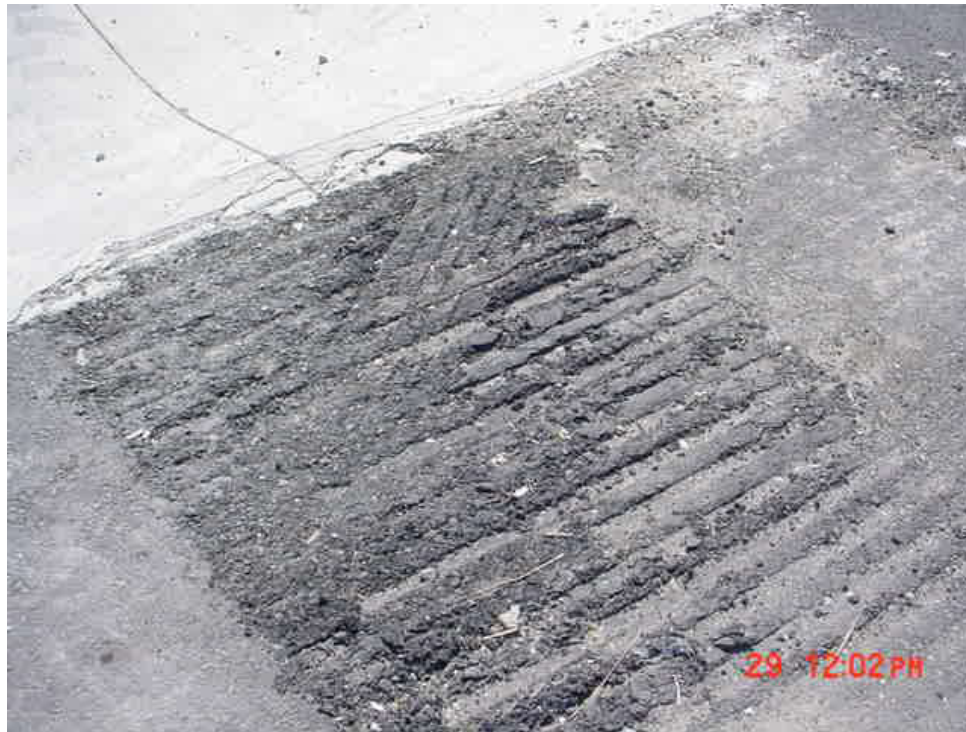
Date	Item	Comments and Action Taken
8/24/04	Asphalt near lined ditch CE1 (north of tank farm) damaged by track-mounted vehicle (see Figures A-1, A-3 in Appendix A).	Description of damage provided to responsible party for corrective action (D&D&D). Damage is scheduled for repair by April-May 2005.
8/24/04	Building TB-6 (north of tank farm and within the 150 ft control zone) demolished. Leaves a large opening in the asphalted area.	Footprint of building leaves a large area for surface water infiltration. Item reported to D&D&D management. Area is scheduled to be covered with asphalt in early FY-05.
8/24/04	Asphalt north of lined drainage ditch OA1 (south of tank farm) penetrated in two locations by soil probing equipment.	Penetrations from planned RI/FS soil investigation activities at contamination area CPP-15 RI/FS. Installed probehole casings (above ground) were removed and capped. Flushmount covers will be installed over the capped probehole casings and the damaged asphalt will be repaired. Work is scheduled to be completed in early FY-05.

Figure A-1. Track damage to asphalt near lined drainage ditch CE1.

(a) Asphalt near lined ditch CE1 (north of tank farm) damaged by track-mounted vehicle. (b) Broken concrete on both sides of lined ditch CE1.	Repair will be made under the INTEC Monitoring control account where all maintenance type activities are located.	\$5-10K	May-June 2005
7/19/04	Expansion joint material in ditch BS1 is partly loose on the eastern end.	Replace material.	\$200	May-June 2005
	Reseal.	Annual reseal of asphalt on tank farm.	\$1,000	June-Aug. 2005
1/28/04	Lift station hatch doors have been damaged.	Install metal bracing beneath door frame and bolt to concrete vault.	\$5-6K	May-June 2005

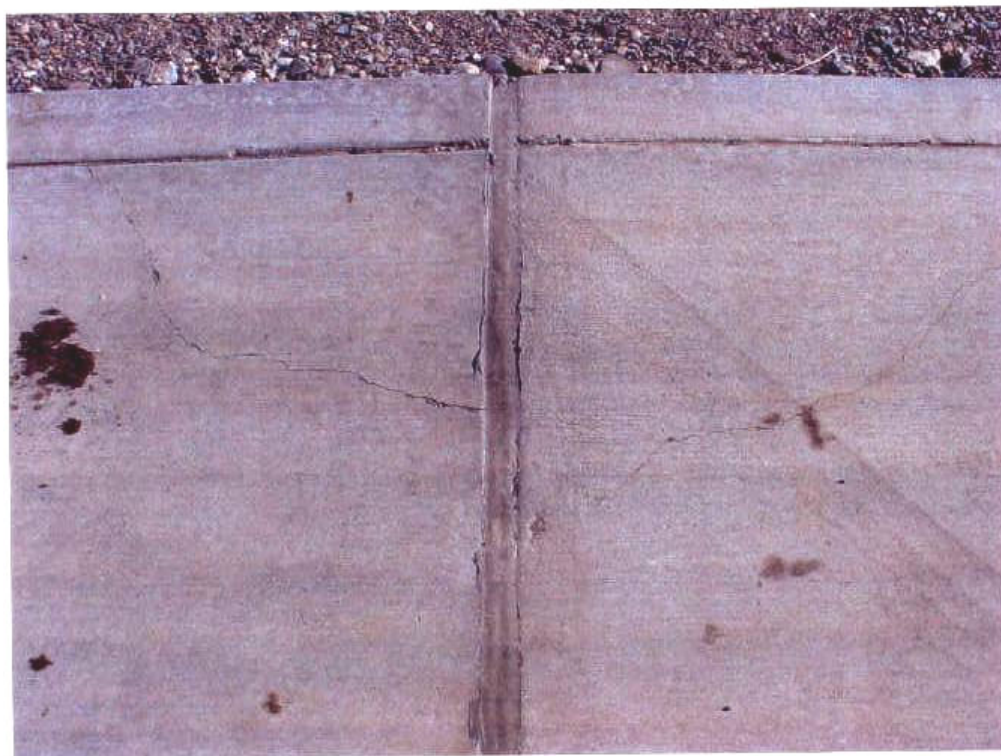
Date	Item	Comments and Action Taken
10/27/03	Two hairline cracks observed on upper edge of lined ditch BS2 (see Figure 2-2).	The reported hairline cracks were photographed in October of 2003 (see Figure A-2 in Appendix A) and inspected monthly for any change. The cracks are located on the upper edged of the concrete-lined drainage ditch, BS2 (see Figure 2-2) where any captured water in the ditch would not flow. The condition of the hairline cracks did not change during the year. Due to the location of these cracks, they do not impact the ability of the system to manage the water and have not been identified for maintenance.
10/27/03	Weeds and cardboard observed in several section of the drainage system.	Laborer foreman contacted. Debris removed per notification.
11/13/04	Weeds and cardboard observed in several sections of the drainage system.	Laborer foreman contacted. Debris removed per notification.

Figure A-2. Hairline cracks in lined drainage ditch BS2.

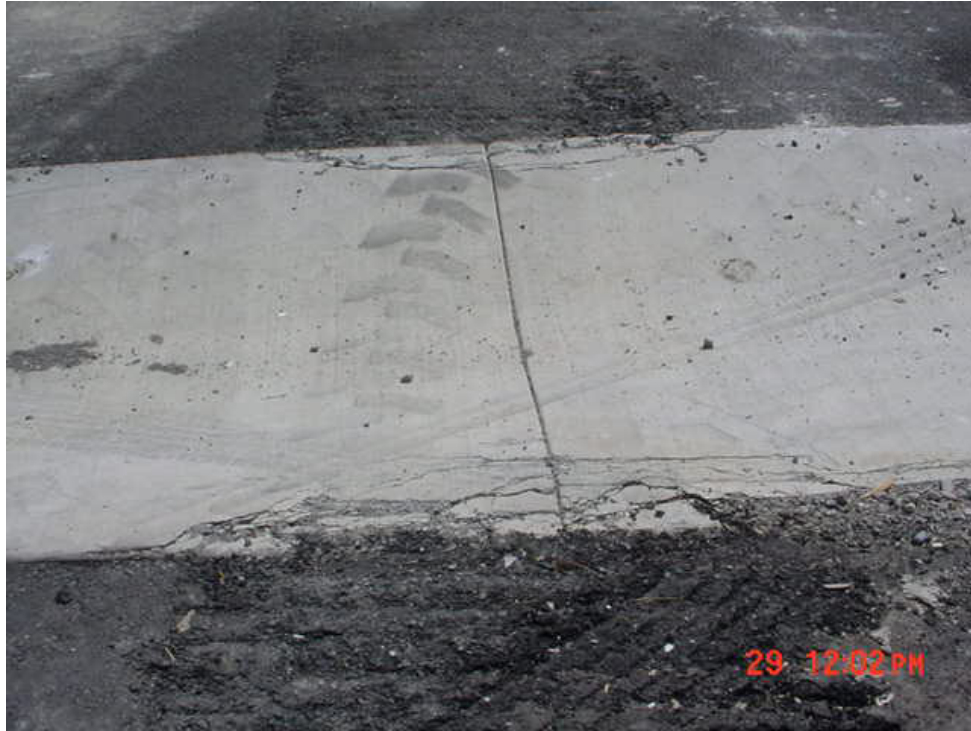
Figure A-3. Track damage to lined ditch CE1.
